Behaviour of interlocking block structures under dynamic loading: A review

Abstract: Earthquake imposes serious harm to non-designed structures in countryside regions of the world. Many affordable yet safe housing strategies for individuals of such regions are being proposed by many researchers. In this regard, interlocking block structure is one of the potential solutions presented by these researchers. The aim of this paper is to review the behaviour of interlocking block prototype structures under dynamic loading based on previous researches. Behaviour of these prototype interlocking structures were investigated by various researchers using low to large scale shake table in the laboratory. Their mechanism of dynamic loading, from real life earthquake phenomena to simplified apparatus in the form of shake table done on prototypes and on real scale, is presented. A brief overview of the parameters evaluated in these studies is also discussed. The viability of different interlocking patterns in increasing the dynamic properties are featured and conclusions drawn are gathered to have a superior understanding of the adequacy of these interlocking patterns against dynamic loading. Th

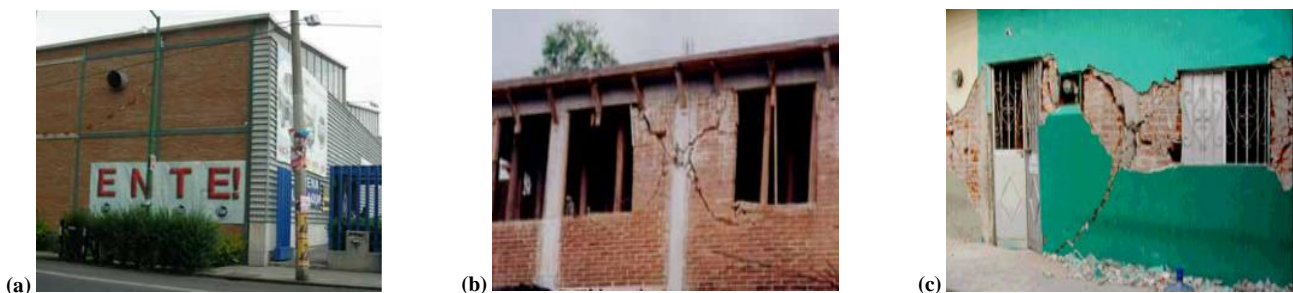
Fig. 5: Confined masonry construction in Mexico (a) an engineered structure in the industrial zone, (b) minor damage of confined masonry (c) major damage of confined masonry due to inadequate confining elements and their arrangement [34]

Mexico country has a long record of using confined masonry technique in their housing construction. It is the most common construction practice in the country, and is widely used in the central part of the country. Confined masonry is usually practiced in the form of engineered and non-engineered construction all over the country. Most of the non-engineered construction found in the rural and sub urban areas, whereas engineered constructed buildings found in the industrial areas and developed housing schemes as shown in the Fig. 5 (a). During the 2003 Tecomán earthquake of magnitude 7.6, confined masonry buildings performed considerably better than unreinforced brick masonry buildings; majority of confined masonry buildings were undamaged or suffered only a minor damage as shown in Fig. 5 (b). Some cases of failure were observed when the number and arrangement of confining elements were inadequate as shown in Fig. 5 (c) [34].

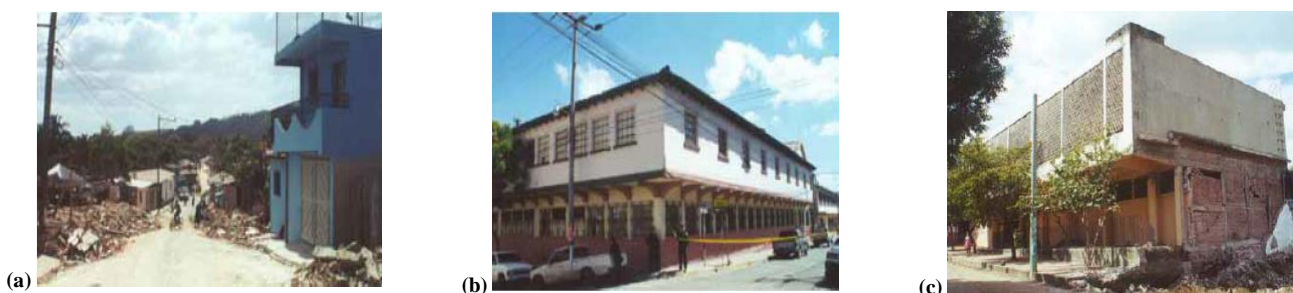
Fig. 6: Behavior of confined masonry during the 2001 El Salvador earthquakes, (a) confined masonry structures in city of Santa Cruz Analquito survived, whereas nearby conventional structures was destroyed, (b) a confined masonry school building survived the earthquake without damage (c) soft story construction (confined masonry construction at the ground floor level) [36]

Similarly, confined masonry buildings performed exceptionally well in the El Salvador earthquakes of 2001 [35]. Confined masonry structures are very common in El Salvador. Almost 60% of the structures in El Salvador were constructed from mixto, a type of confined masonry with closely spaced tie-beams and small tie-column spacing. Over 90% of the buildings of this type were undamaged; only 5.9% of confined masonry or concrete buildings faced repairable damage, whereas 2.4% of the buildings were damaged beyond repair. Among the damaged buildings of this type, there were a few cases of wall shear failure, as well as out-of-plane wall failures, where the wall toppled outwards in spite of the confining elements. The study concluded that most of the damaged or collapsed structures during the earthquakes were of conventional masonry construction [36].
