Adaptive Reuse Main Strategies for Heritage Building to Boutique Hotel-A Case Study of Sahib Mahal at Badin District

Geeta Khatri¹ and Ajay Kumar Khatri²

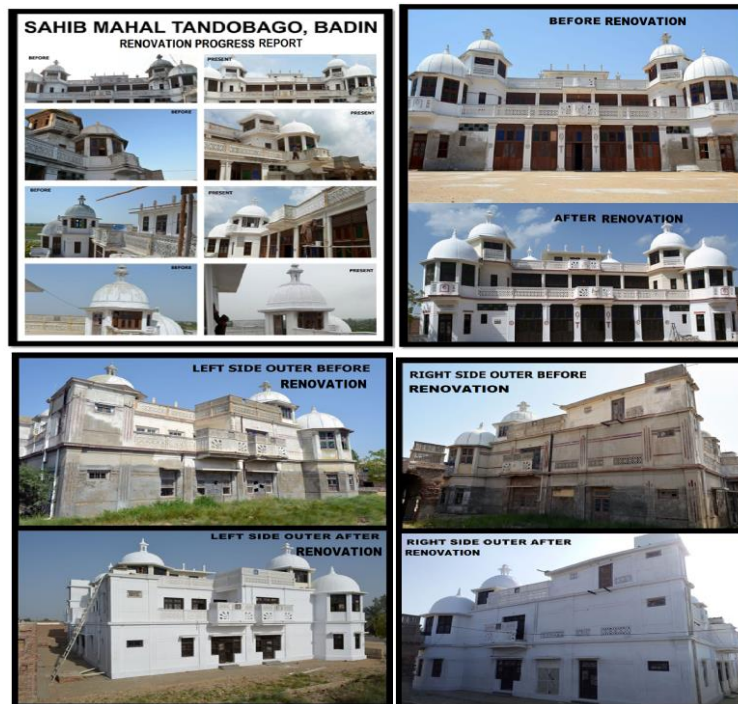
Fig.5: Exterior views before and after renovation of “Sahib Mahal Badin”

Physical change is focused on building physical renovation, Sabib Mahal is facing many problems, structural, architectural and various other monument related problems. Sahib Mahal was left vacant for a period of time, the physical condition was in disrepair due to lack of use. Mir ali akbar talpur is now a caretaker of this mahal but because of the less interest it has become the damage palace with no renovation.

archaeological fields. Data on physical change were collected from secondary data, survey, and in-depth interview from “Sahib Mahal” owner. Sahib Mahal was recently renovated by culture and archaeological department. Several views are shown in figures below.

Culture department should pay the price of property and undertake this property to renovate this heritage building because of the infrastructure of the mahal has a much importance regarding the historical aspect and also according to the cultural and

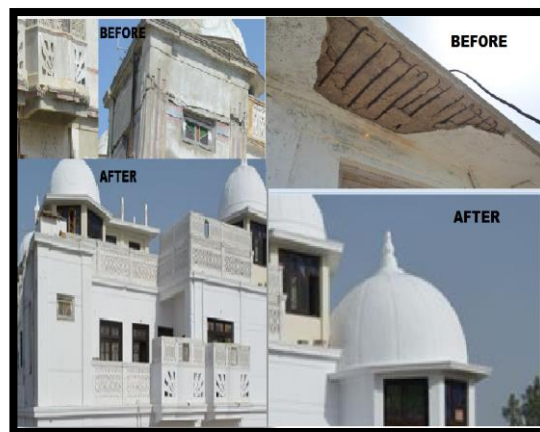
Fig. 6: Views of structural renovation of “Sahib Mahal Badin”

As for the “Building’s Structural Strength”, the column, beam, floor, and roof framing were all in not good condition. There was change in structural strength after renovation.

Reinforcement used in beams, columns, and roof slabs it is not found in good condition some portions the reinforcement bars appeared and rusted due to humidity or weathering affects needs renovation of bars. Some views are shown in Figures below.

Columns constructed with R.c.c and chips work is found over columns and found in average condition. All cantilever beams found to be damaged, needs repairing work some of them should be dismantled and needs re-fix. Floor inside the building is made with cemented tiles which are in not good condition and floor tile should be removed out and levelling concreting and replacing with new tiles with same specification, material and techniques used and were improved after the renovation.

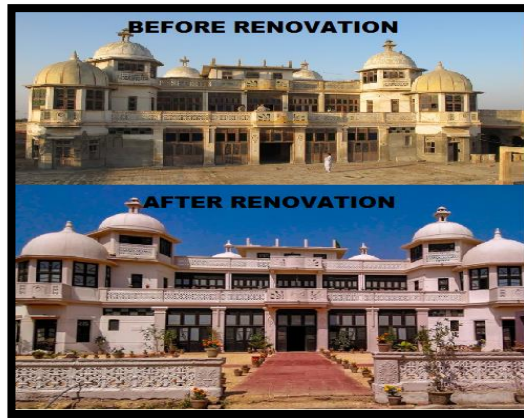
Fig. 7: Architectural condition before and after renovation of “Sahib Mahal Badin”

For the “Building Architectural Condition”, the former conditions of the brick wall, false ceiling, and door-window system were low level and got better after renovation.

Architectural work on outer sides of building found in week condition, it is much improved after the renovation. Several

White and grey deposits found on brick masonry walls of the mahal it shows the presence of soluble salt due to salinity problem & humidity, wall needs water proofing coat at least 2' from ground level to control the dampness, colour of walls almost scratched, distemping required.

Whole building is plastered with cement except two walls in 1st main entrance veranda walls only finishing layer of lime plaster found and white wash is done on it, plaster is almost removed & cracks are occurred on it, it needs removing of old plaster & required re-plaster.

Plaster and brick masonry is deteriorated from various parts of building because of water logging and salinity problem.

All doors, windows and ventilators found in worst condition after renovation these are cleaning, repairing, replacing of glass and polishing.

All of the finishing materials such as floor and wall finishing materials were in dilapidated condition and were improved after the renovation.

The former plaster of compound wall, sahib mahal walls, kitchen and swimming pool should be removed and re-plastered after renovation.

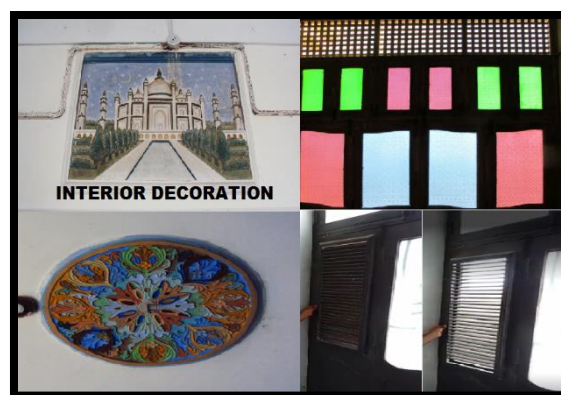
Fig. 8: Interior decoration of “Sahib Mahal Badin”

As for the interior conditions, all built-in furniture, movable furniture, and decoration were previously presented but, after renovation they were installed in good condition, except the appliances were not available. Several views of the interior are shown in Figure:

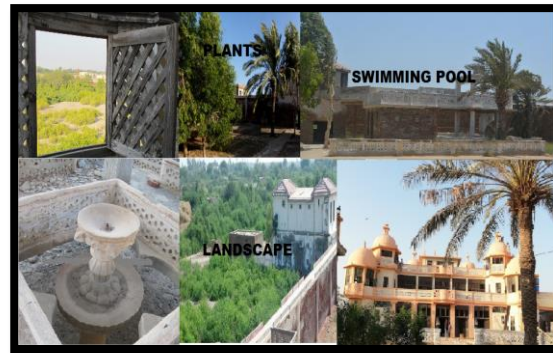
Fig. 9: Exterior views of landscape, plants & fence of “Sahib Mahal Badin”

Lastly, as for the exterior and the surroundings, previous landscape, plants and fences had been present form but after renovation there were much improve and good condition. Several views of the exterior are shown in Figure:

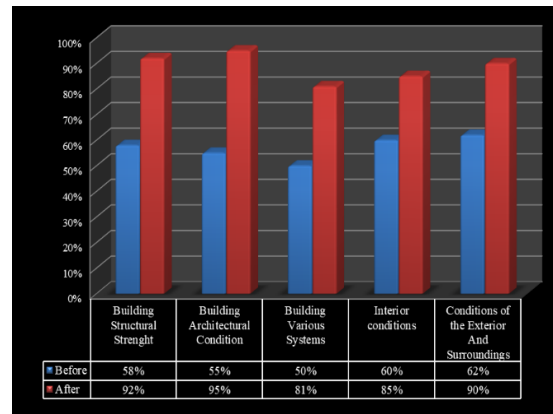
Fig10: The bar chart shows that a summary with numerical evaluations of the physical changes
